Elsyng Palace Excavations 2021 Martin J. Dearne (Illustrations by Neil and John Pinchbeck and the author)

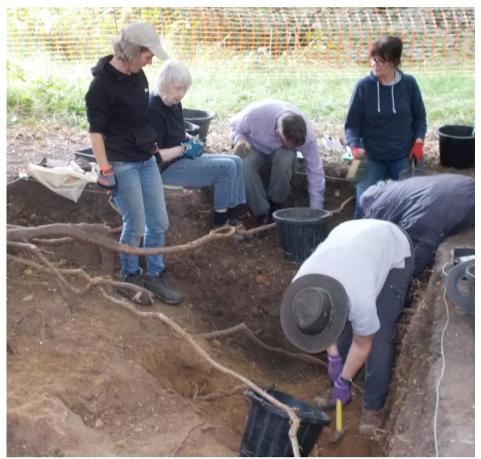
Fig. 2: Excavation of the gatehouse robber trench in progress

In the event we had a lot of trouble tracing the ?water supply channel further because repeated tree planting in the avenue had damaged it, but eventually it was found and ruled out as feeding the moat (it now seems likely that it fed a cistern in the outer court). Traces of the gatehouse itself also seemed to be absent at first, what we found comprising two or three external rammed pebble surfaces, one flanked by a little gully filled with demolition rubble. However, a little further west than we had initially thought it might be from the (admittedly very limited) documentary evidence we had, and as always towards the end of the dig (!), another rubble deposit became deeper and deeper and was found to be filling a cut into the ground so large and deep that not even both sides of it were within our trench despite expanding it twice (Fig. 2). Almost certainly a robber trench where a substantial wall had been removed, the cut suggests that we have indeed located some part of the gatehouse. Which part remains to be seen as it would have been a very large structure including things like projecting stair towers and we will need to see its walls, or the trenches from their robbing, at several points before we can judge how what we have found relates to the rest of the building.
